SPECIAL BOARD MEETING

Subject: Engineering Services for the Replacement of Damaged Lining at the North Hill St. Canal

ANDERSON-COTTONWOOD IRRIGATION DISTRICT MAIN CANAL AND CHURN CREEK AREA WATER LOSS EVALUATION

SHASTA COUNTY, CALIFORNIA MAY 2025

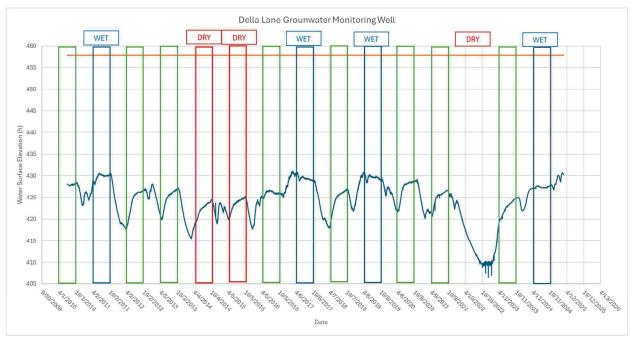
Figure 3-1. Della Lane Groundwater Monitoring Well

Figure 3-1 shows the groundwater data for the period of record. Within the boxes (April-October) is ACID's typical operating period. Red boxes are extremely dry years, blue boxes are very wet years, and green boxes are close to average years. During 2022, ACID did not run its Canal, and it was an extreme drought year.

The monitoring well includes additional casings that range in depth up to 200' below ground surface elevation. Groundwater levels in these deeper casings do not appear to show fluctuations related to seepage for the Canal. There is data available from June 30th, 2010, through March 10th, 2025.

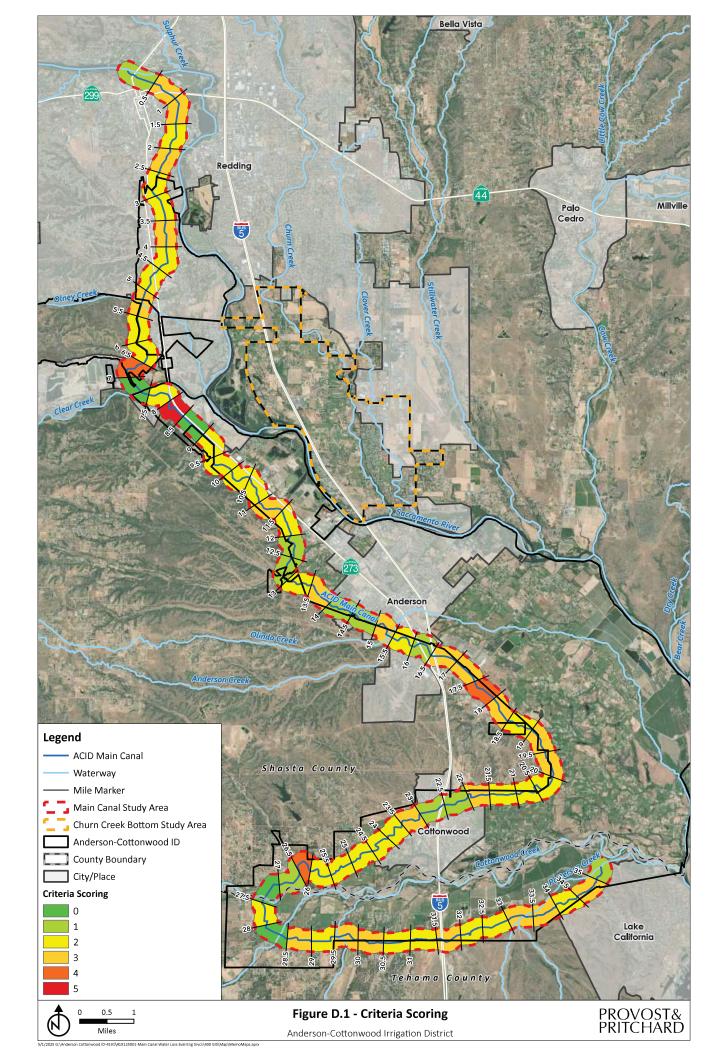
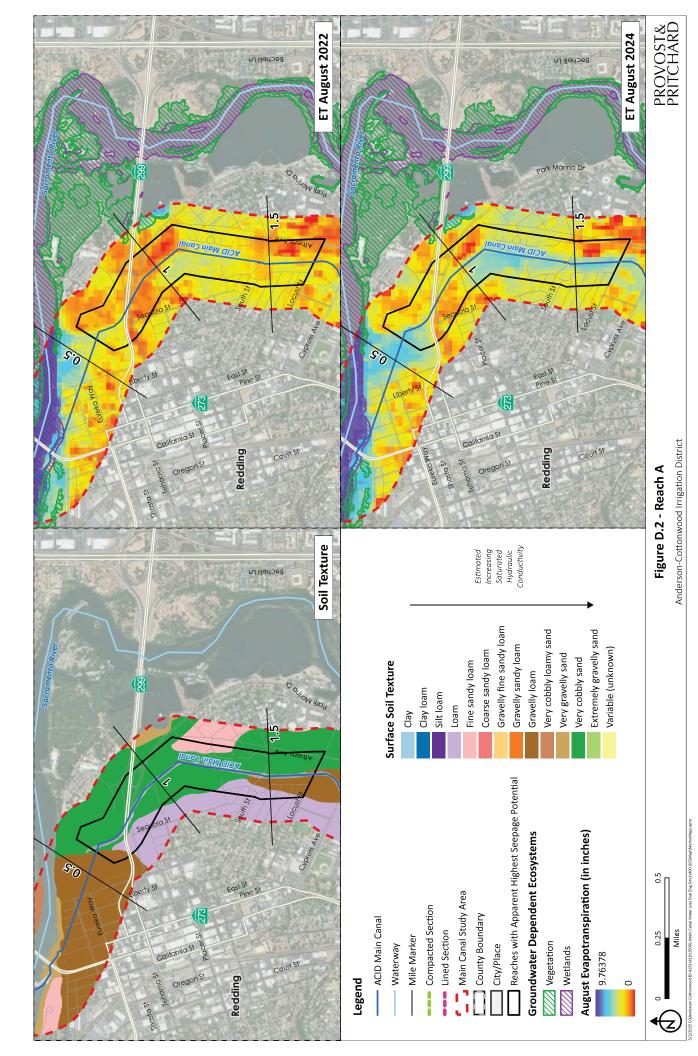
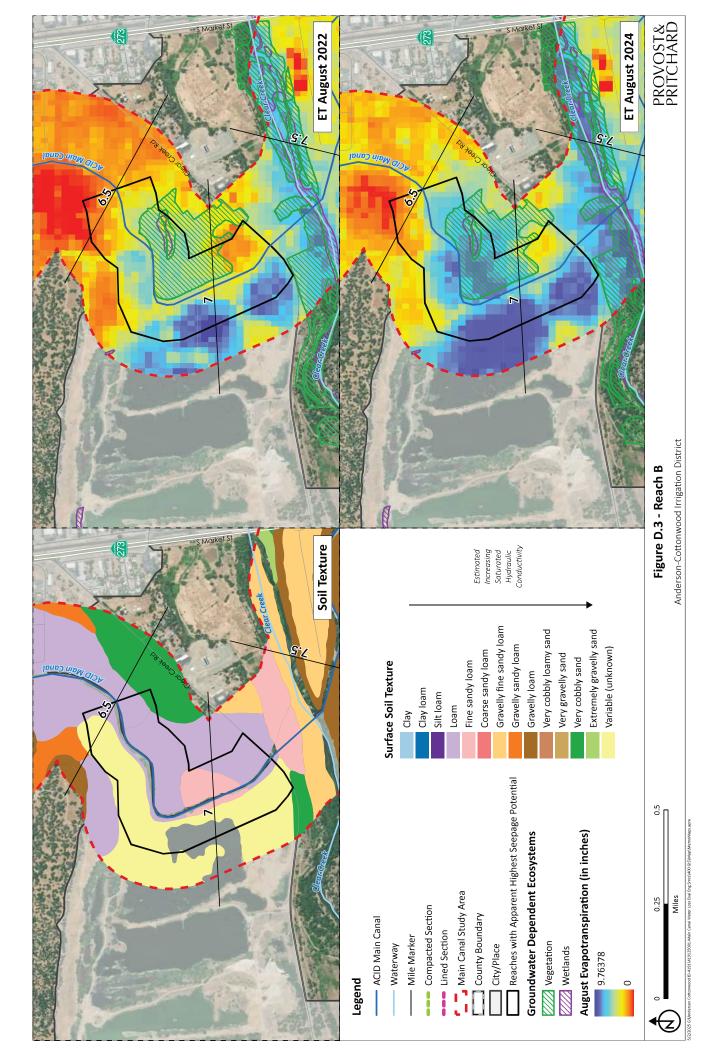
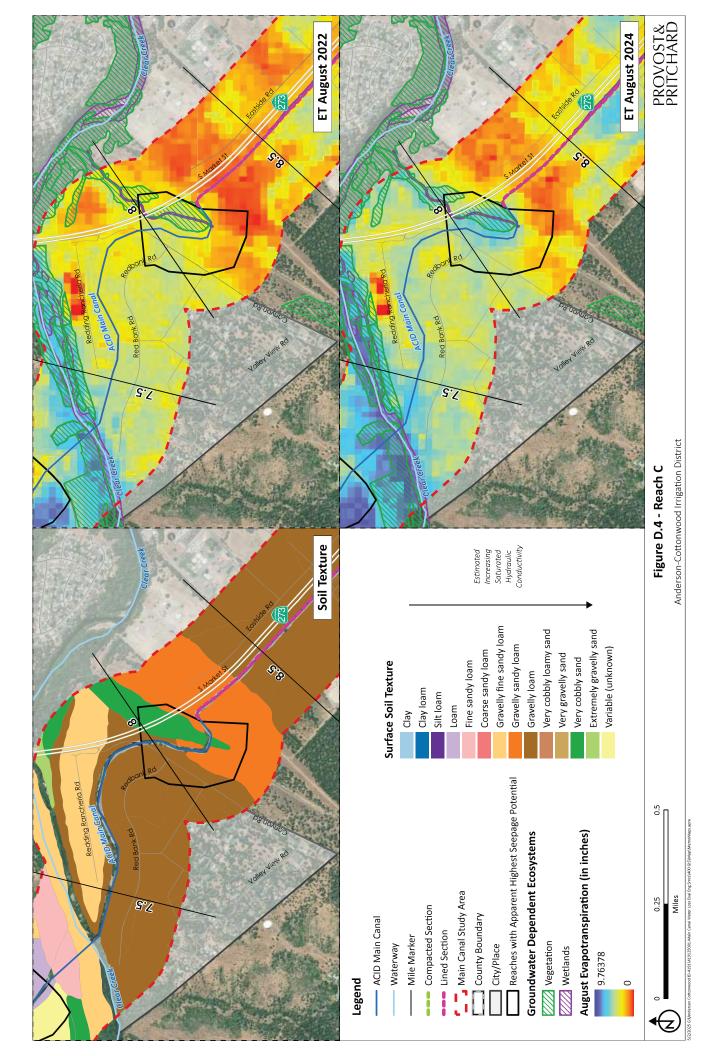
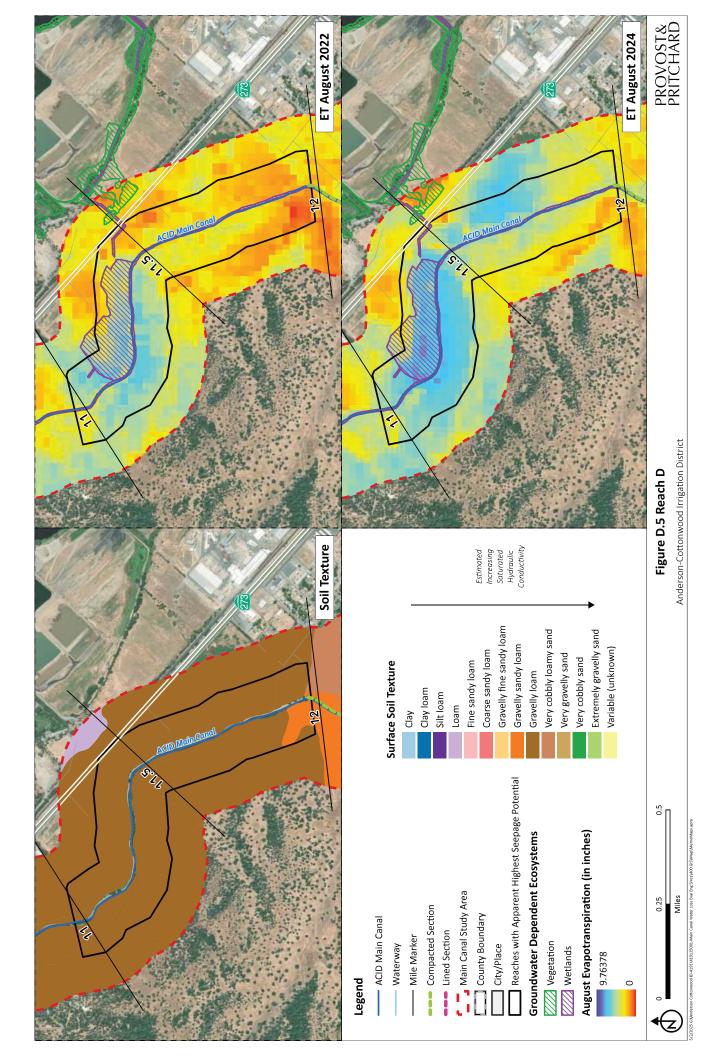
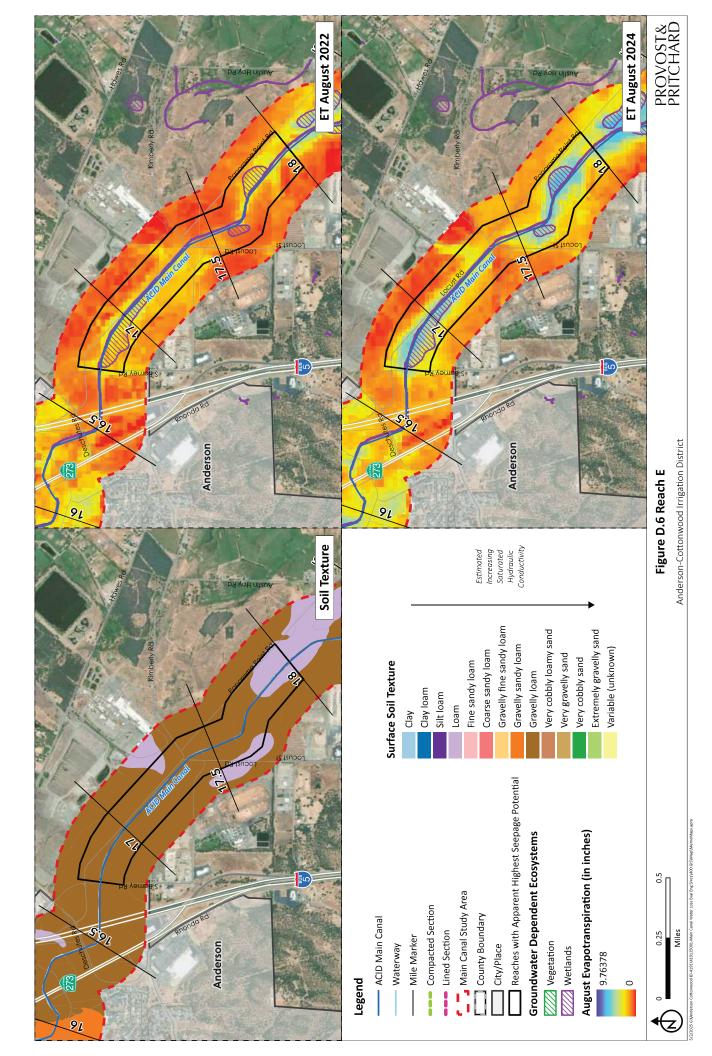
APPENDIX D

Reach C begins at Canyon Road and ends at the existing concrete lining along Highway 273. Reach C crosses a natural drainage which is intersected by the Canal. Reach C scored high in hydraulic conductivity, high in SAGBI, high in surface texture (very cobbly sand and gravelly sandy loam), high in Open ET, and has both wetland GDEs and vegetation GDEs. This reach is believed to cause water surfacing in a historical drainage that flows down into the Sacramento River. See **Appendix D** for a map showing Reach C.
